# V12 and probably V9-V10 DEAD BEEF SYNDROME

v.0.95

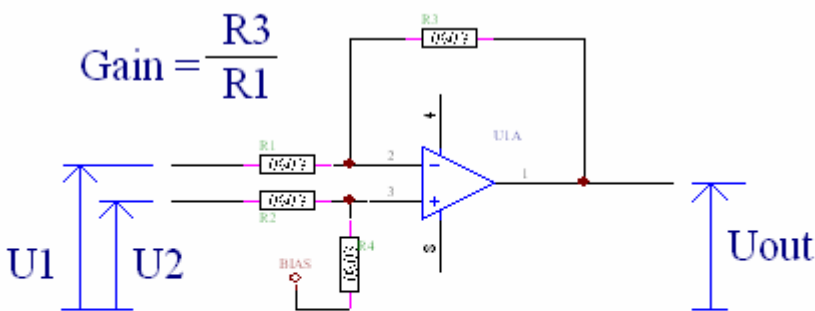
Op-amp circuit (Figure3)

As you can see on above images the LA/BA chip amplifies only the difference what is shown on math M1 waveform from the scope. Very simplified formula for such circuit is shown below. We said Very simplified because we omitted bias value and we assume that ratio  $R3/R1=R4/R2$  (what is not off course true in PStwo circuit but it is only approximation for the next analysis). Let's assume that  $U_{out} = \text{Gain} * (U2 - U1)$ .

Very! Simplified  $U_{out}$  formula

$$U_{out} = \text{Gain}(U2 - U1)$$
